**DEPARTMENT OF TRANSPORTATION**

Contract #: 04-0120F4Cty: SF/ALA Rte: 80 PM: 13.2/13.9File #: 69.28**WELDING INSPECTION REPORT****Resident Engineer:**Pursell, Gary**Address:** 333 Burma Road**City:** Oakland, CA 94607**Report No:** WIR-000390**Date Inspected:** 22-Aug-2007**Project Name:** SAS Superstructure**OSM Arrival Time:** 800**Prime Contractor:** American Bridge/Fluor Enterprises, a JV**OSM Departure Time:** 2100**Contractor:** Zhenhua Port Machinery Company, Ltd (ZPMC), Changxing Island **Location:** Shanghai, China**CWI Name:** Xue Yian**CWI Present:** Yes No**Inspected CWI report:** Yes No N/A**Rod Oven in Use:** Yes No N/A**Electrode to specification:** Yes No N/A**Weld Procedures Followed:** Yes No N/A**Qualified Welders:** Yes No N/A**Verified Joint Fit-up:** Yes No N/A**Approved Drawings:** Yes No N/A**Approved WPS:** Yes No N/A**Delayed / Cancelled:** Yes No N/A**Bridge No:** 34-0006**Component:** MTR's / 77 Meter mock-up**Summary of Items Observed:**

**77 Mockup-skin plate D side 1:**

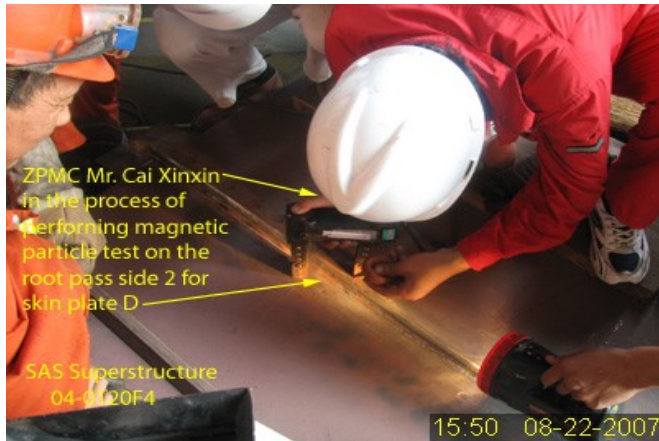
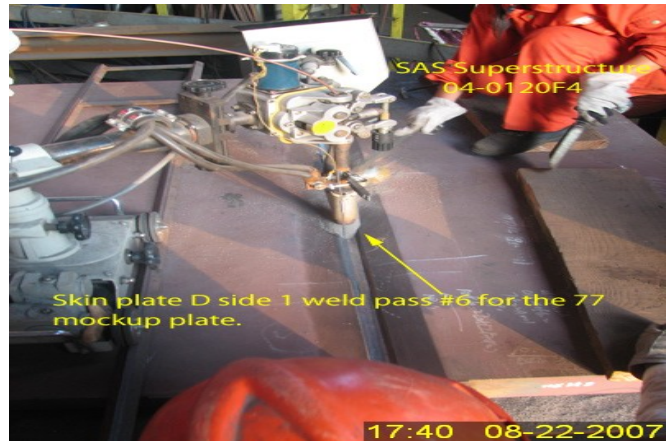
77 Mockup-skin plate D side 1: QA Inspector Brannon periodically observed ZPMC qualified welder Mr. Xue Yian ID#040634 groove welding twelve fill passes on side 1 joining MK# MA5 to mp14 for skin plate D. Mr. Yian was observed welding in the 1G (flat), position utilizing a submerged arc welding (SAW) process using a 4.8mm diameter electrode, filler metal classification JW-3 EM12K on a motorized track. Mr. Yian appeared to be using proper inter-pass cleaning methods. QA Inspector Brannon observed preheat and welding parameters measured by the ZPMC QC Inspector Xu Lefeng, observed by QA Inspector Brannon appeared to be in general compliance with the approved Welding Procedure Specification, WPS-B-T-2321-B-P3-S, and revision 0.

The following digital photographs provides additional detail.
